## Plating Organics: Hidden Defects

*By: Jason Gjesvold*

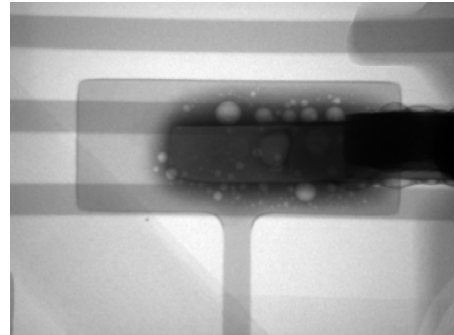
Recently we received some hardware that exhibited failures at a specific multi-use socket. The socket originally came under scrutiny because of weak solder connections that were cracking during final integration resulting in electrical failure of the product. Real time x-ray analysis (RTX) performed on the connections confirmed the presence of significant voiding as illustrated in Figure 1. Upon studying the reflow profile used in the board assembly and after numerous teleconferences discussing factors related to the reflow, it was unclear as to the source of the voiding. We were assured that the humidity at the time of paste and reflow was maintained at or below 25-30%. Additionally, the process time had been minimized to ensure the flux in the paste did not dry out too soon. What was the root cause of the massive voiding? Why didn't other leaded devices exhibit similar voiding?

Figure 1. RTX Image of Socket Lead

increase throwing power. Invariably, some of the organics are co-deposited onto the target surface during plating. These organics, if present in high enough concentrations, will outgas at reflow temperatures and cause the voiding that was discovered on this hardware.

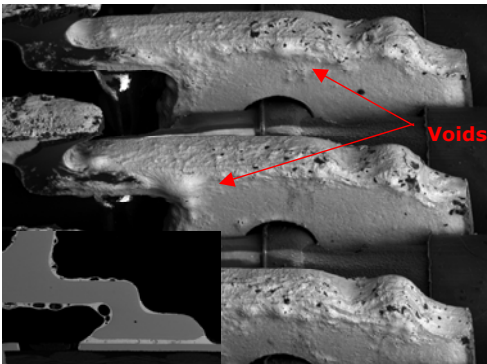
To further investigate the phenomenon, a socket that failed due to fractured solder connections was analyzed in our scanning electron microscope (SEM). Energy dispersive x-ray spectrometer (EDS) analysis of the lead indicated the fracture occurred very close to a Nickel (Ni) diffusion boundary layer since Ni was detected in the EDS spectrum. Cross sectional analysis of good connections indicated Ni plating was not present on the surface of the board, therefore the fracture location was confirmed as occurring at the lead interface. Also discovered was the appearance of voids in the upper portions of the socket leads as illustrated by Figure 2. The location of the voids was not consistent with voiding that would be initiated by binders in the solder determined to be caused by occluded organic impurities or contamination in the plating process of the leads.

Figure 2. SEM Analysis of Lead (Microsection inset)
